Quality Improvements

Project Title	Management of Fallen Springs
Presenter Names	Amit Cholekar
Team	Tushar, Chandraprakash, Jayesh & Latika

Fallen spring analysis

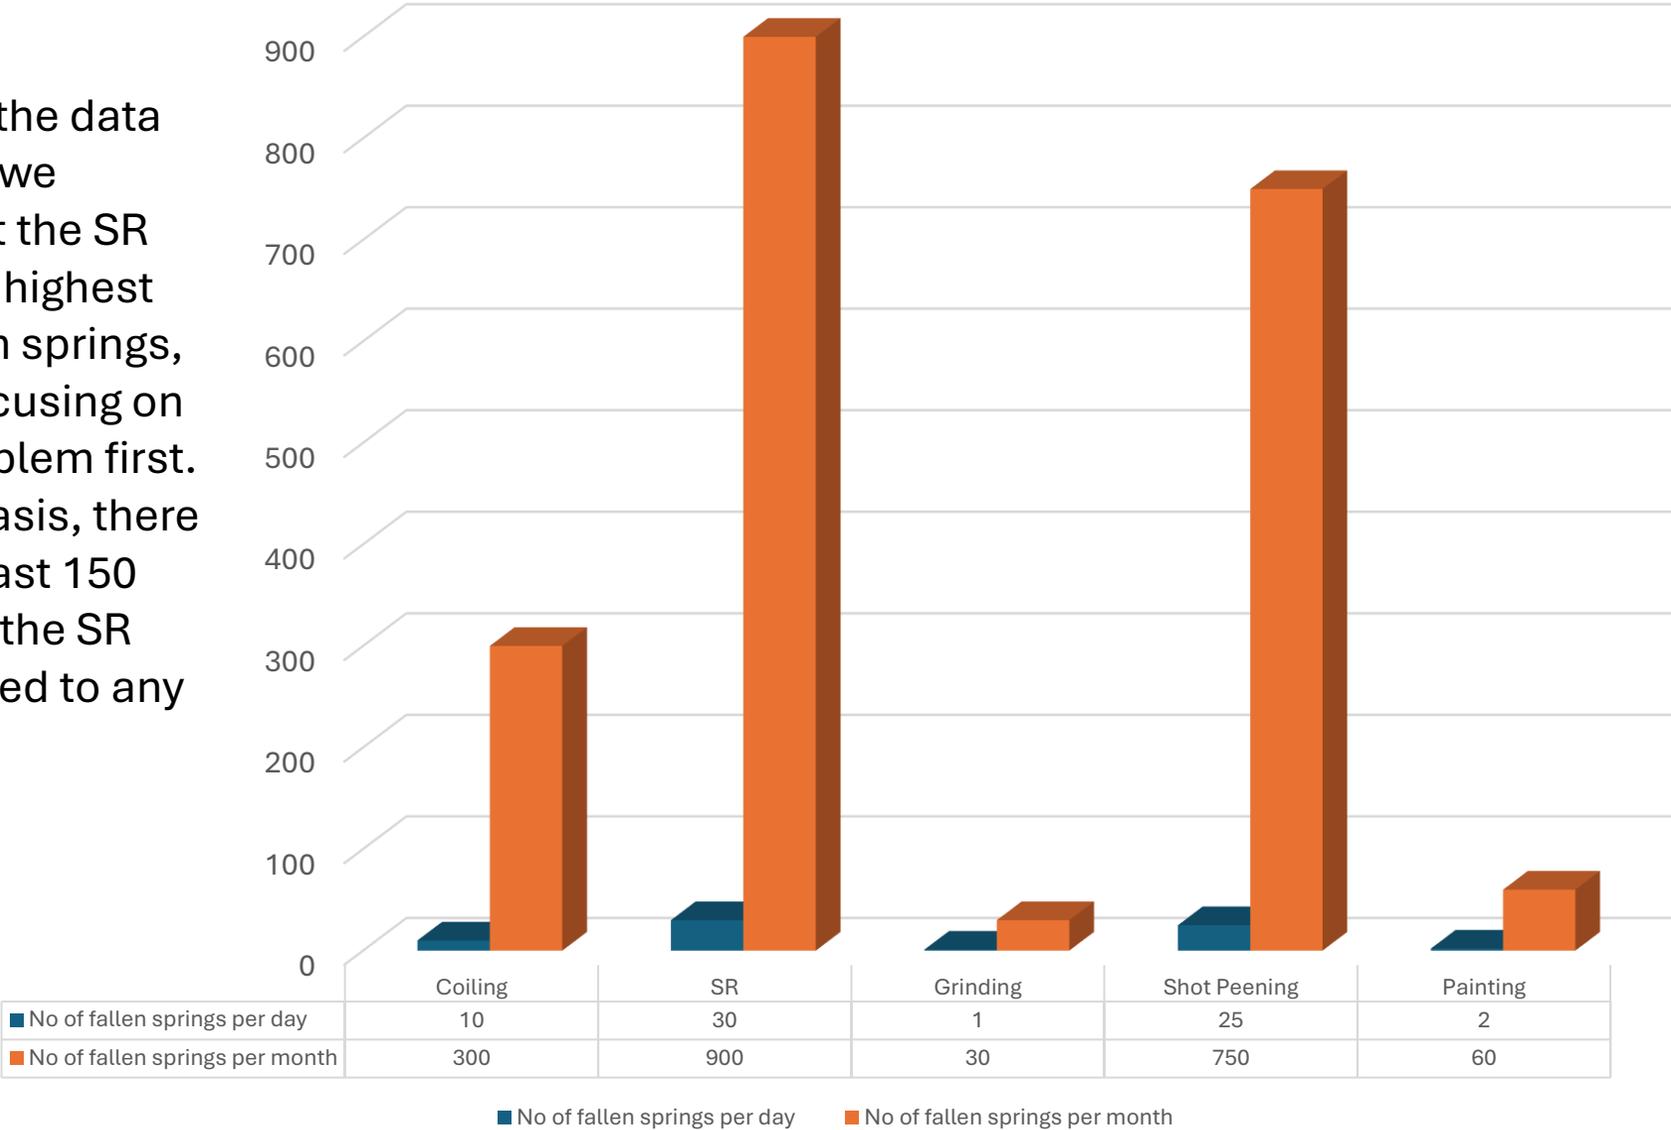
After looking at the data from the graph, we determined that the SR section had the highest amount of fallen springs, leading to us focusing on solving that problem first. On a monthly basis, there is a loss of at least 150 more springs in the SR section compared to any other process.

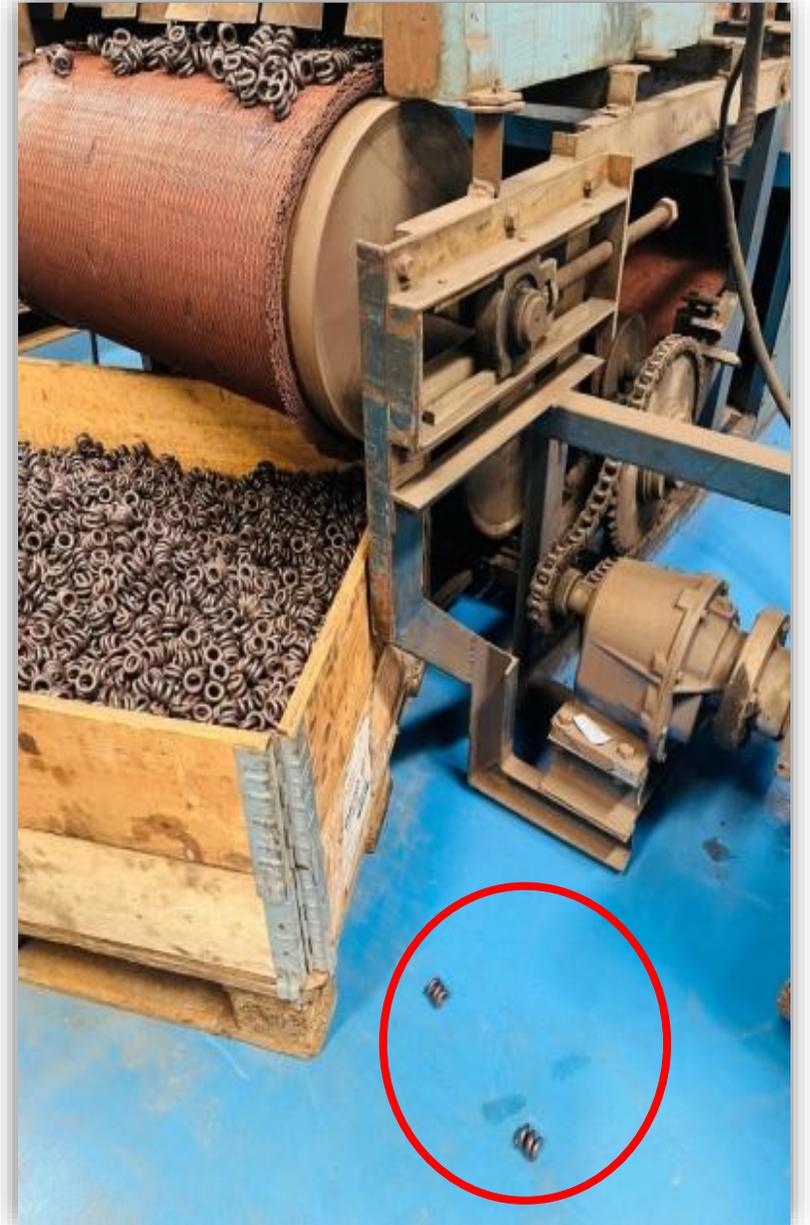
- Springs often spill from the SR furnace container, needing manual cleanup, which seems like an easily fixable issue.
- This problem has worsened recently, leaving a cluttered shop floor and needing constant attention.
- As some parts are lost due to the spillage, the quantity collected after the SR is lower than that produced. This leads to their being fewer parts at the end, making it difficult to meet the required number of parts when dispatched which affects the sales.
- Increased scrap that cannot be used. Leading to wastage and an increased cost.

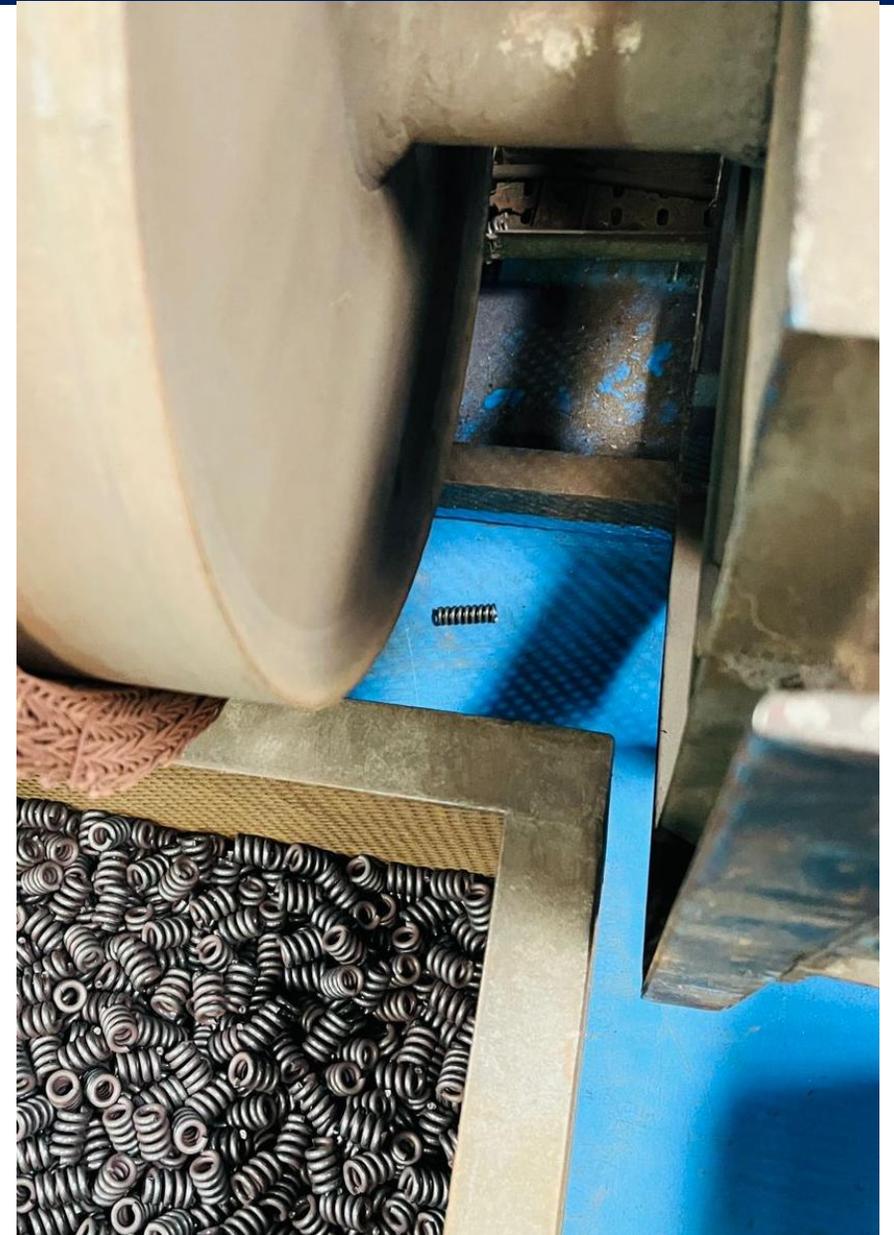
- Visual Analysis of the clutter around the space. Supervision showed that there was constant clean up required.
- A sample of a fallen spring can be seen below. Due to the tight corners, it is understandably difficult why many springs are not collected and added back to the collection crate.
